The Road Inventory of Middle Mississippi National Wildlife Refuge Rockwood, IL

Prepared By:
Federal Highway Administration
Central Federal Lands Highway Division
December 2009

Middle Mississippi River

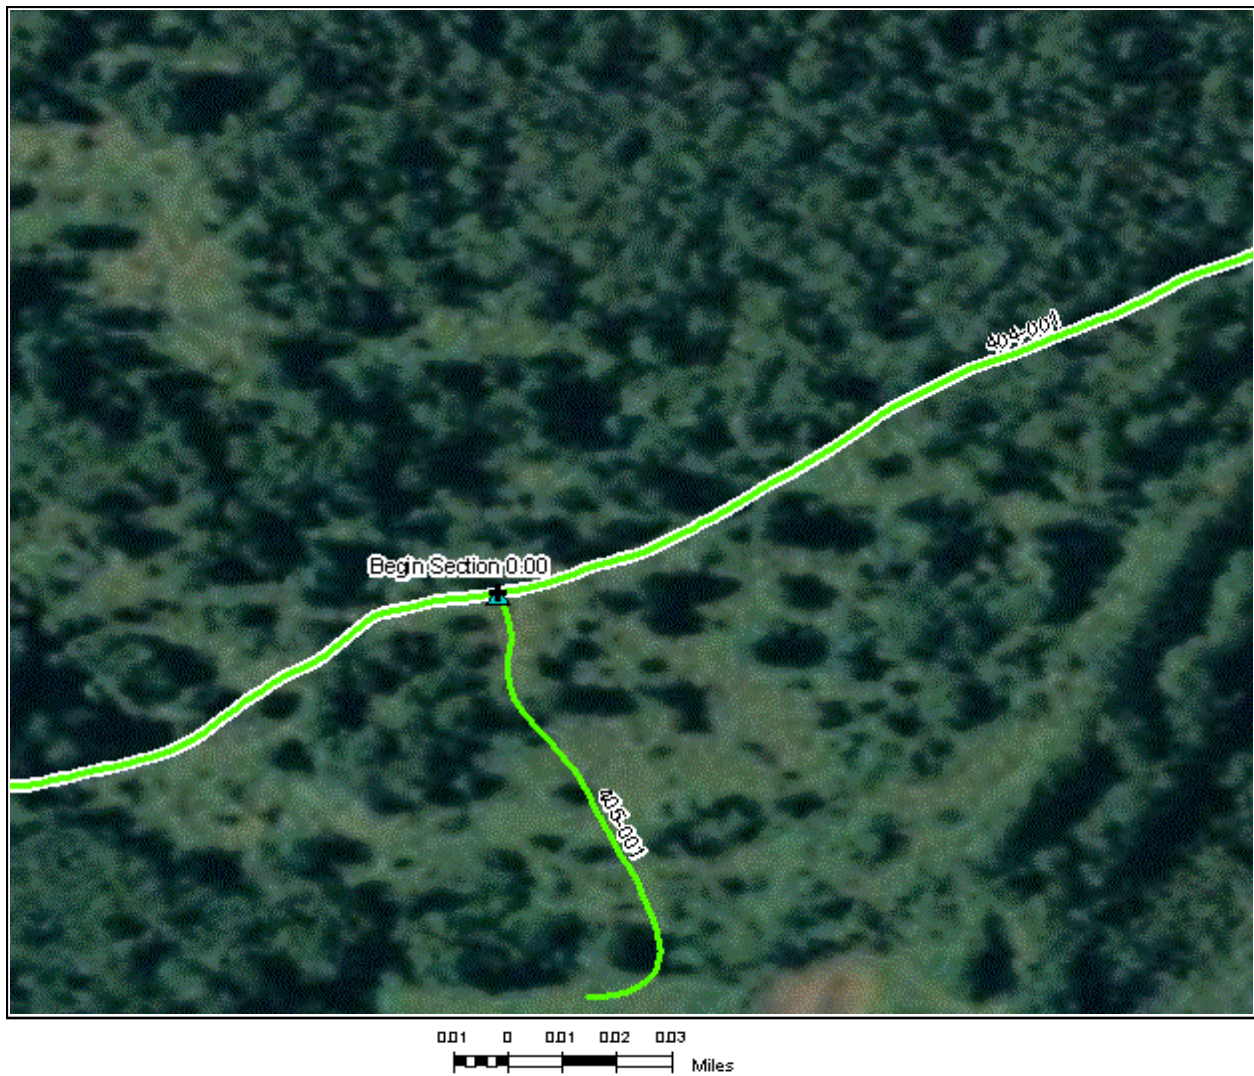
Route: 404 Middle Wilkinson Island Access Connector Road

Route Description: From Wilkenson Island Center Access Road (Route 403) to end of route at problem area

Asset Number	10061152
Section Number	001
Section Length (miles)	0.25
Inspection Date	10/01/2009
Section Information	
Surface Type	Primitive
Number of Lanes	1
Roadway Width (feet)	10.00
Roadway Condition Information	
Condition	Good
Remaining Service Life (years)	5
Cost Estimate	100
CRV	0.00

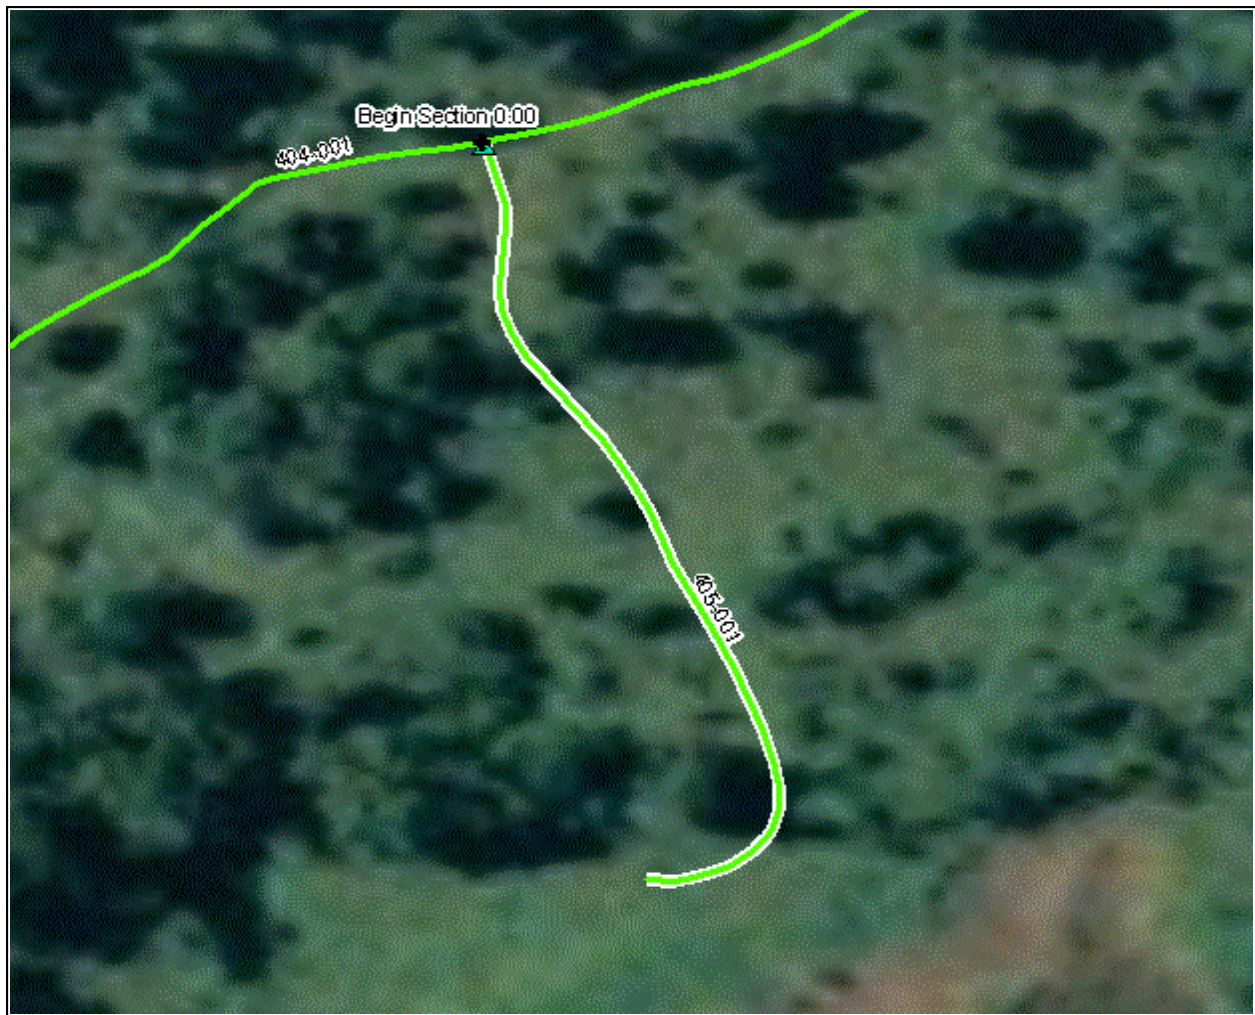
Route: 405 Middle Wilkinson Island Access Spur Road

Route Description: From Middle Wilkinson Island Access Connector Road (Route 404) to end of distinguishable route

Asset Number	10061157
Section Number	001
Section Length (miles)	0.08
Inspection Date	10/01/2009
Section Information	
Surface Type	Primitive
Number of Lanes	1
Roadway Width (feet)	10.00
Roadway Condition Information	
Condition	Good
Remaining Service Life (years)	7
Cost Estimate	0
CRV	0.00

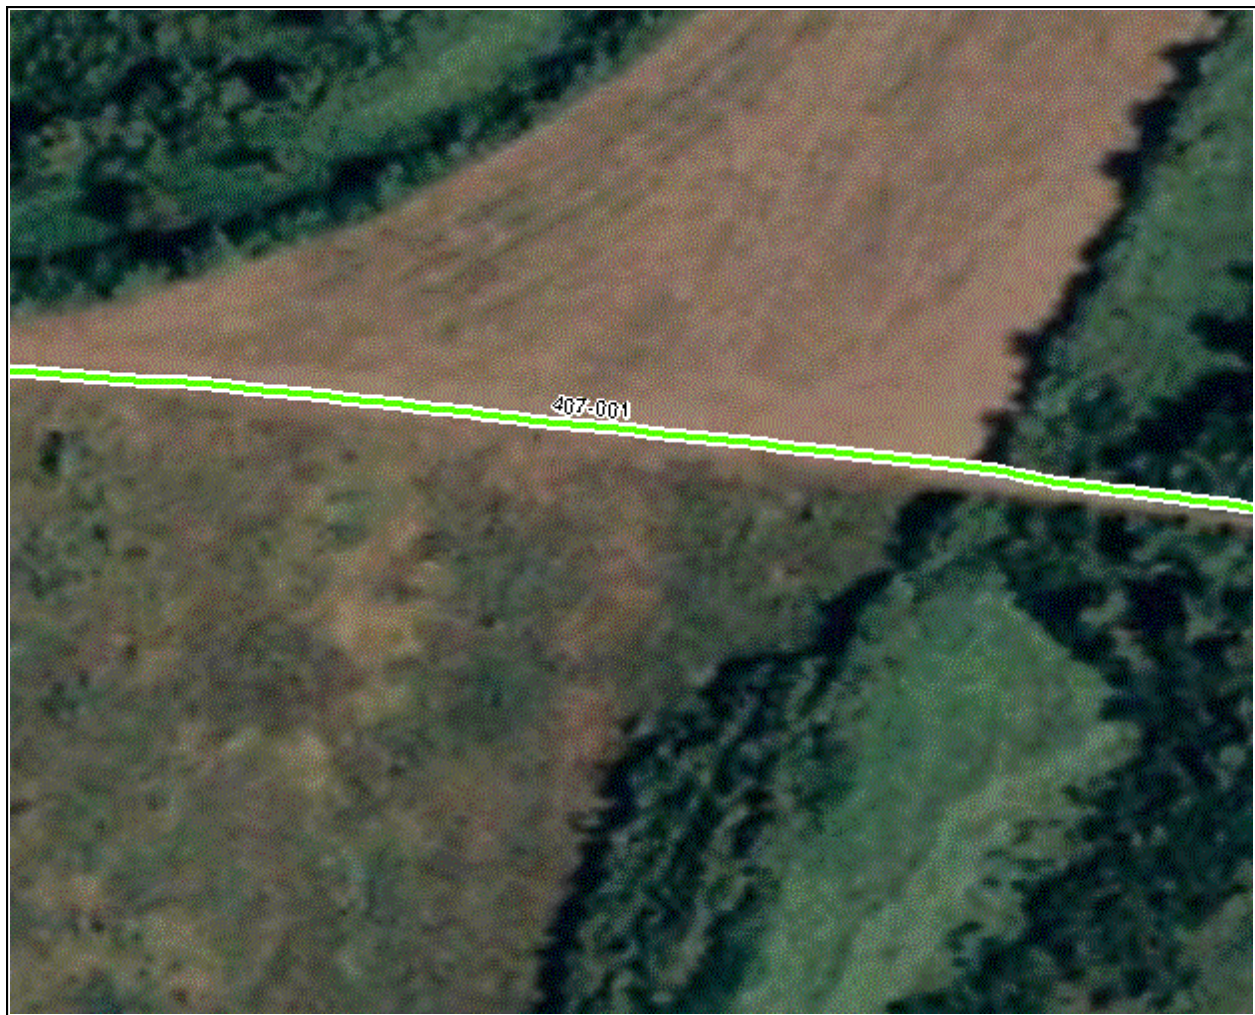
Route: 407 Meissner Island Service Road

Route Description: From Meissner Island Parking (Route 907) to end of route at problem area

Asset Number	10061184
Section Number	001
Section Length (miles)	0.24
Inspection Date	10/01/2009
Section Information	
Surface Type	Primitive
Number of Lanes	1
Roadway Width (feet)	10.00
Roadway Condition Information	
Condition	Good
Remaining Service Life (years)	7
Cost Estimate	100
CRV	0.00

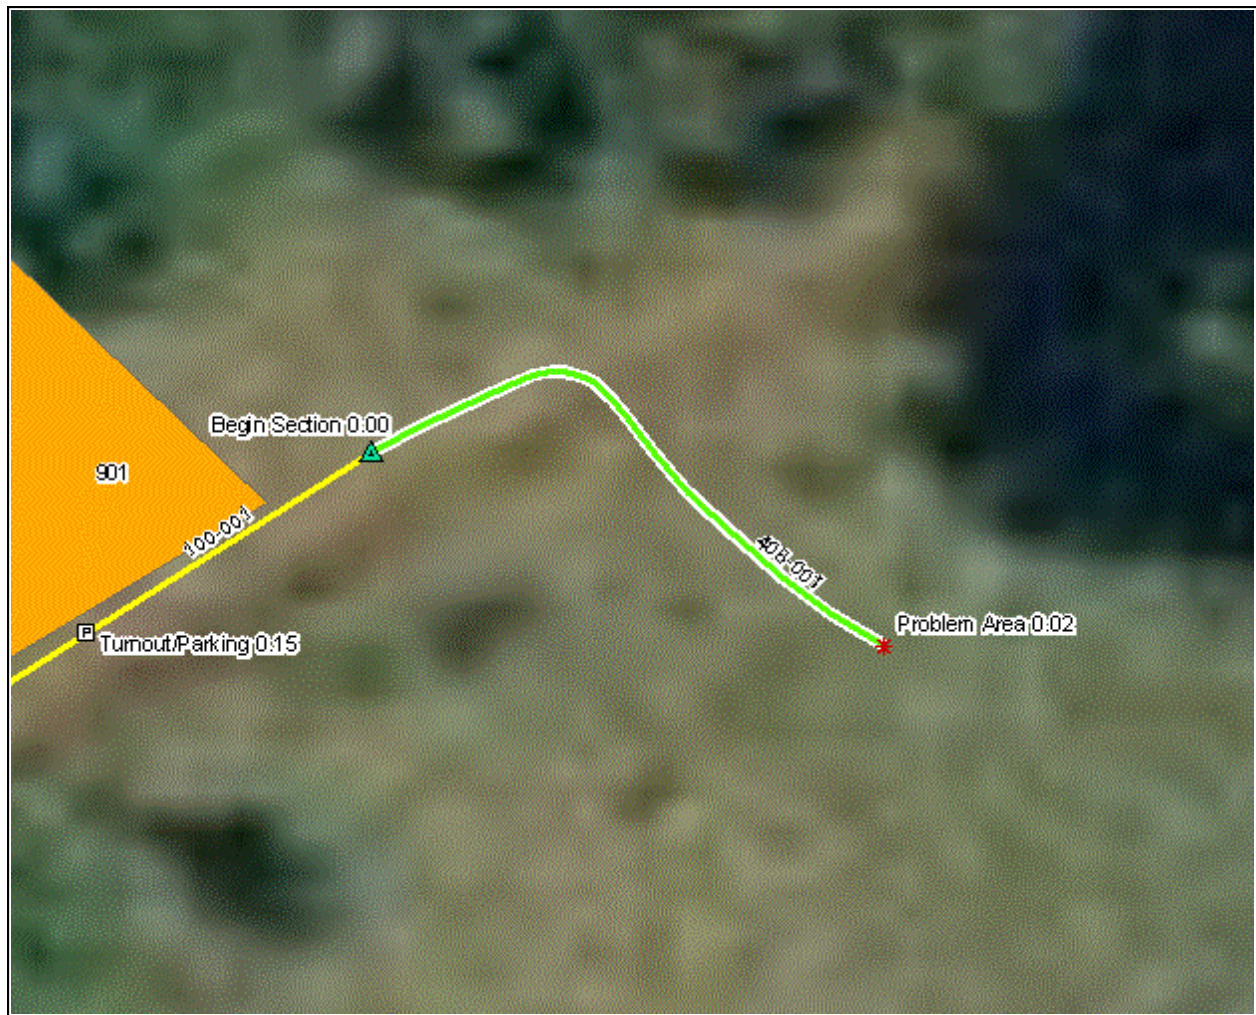
Route: 408 Middle Harlow Island Service Road

Route Description: From Middle Harlow Island Access Road (Route 100) to end of route at problem area

Asset Number	10061180
Section Number	001
Section Length (miles)	0.02
Inspection Date	10/01/2009
Section Information	
Surface Type	Primitive
Number of Lanes	1
Roadway Width (feet)	8.00
Roadway Condition Information	
Condition	Good
Remaining Service Life (years)	5
Cost Estimate	0
CRV	0.00

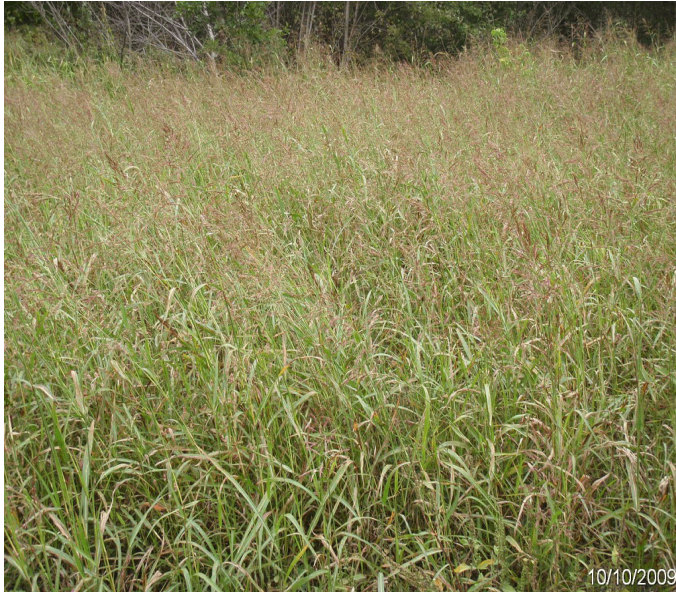
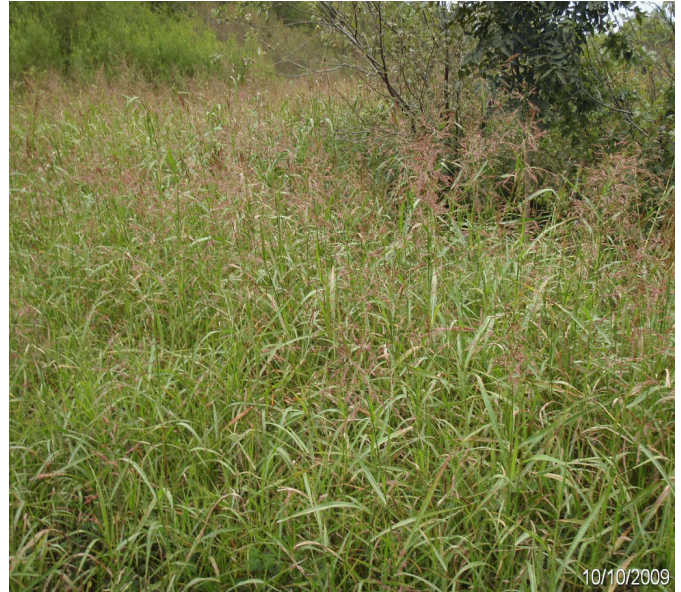
901: Middle Harlow Island Access Parking

Asset Number	Date Visited	Surface Type	Area (Sq Ft)	Condition	Cost to Improve
10043507	10/01/2009	Primitive	5,890	Poor	0

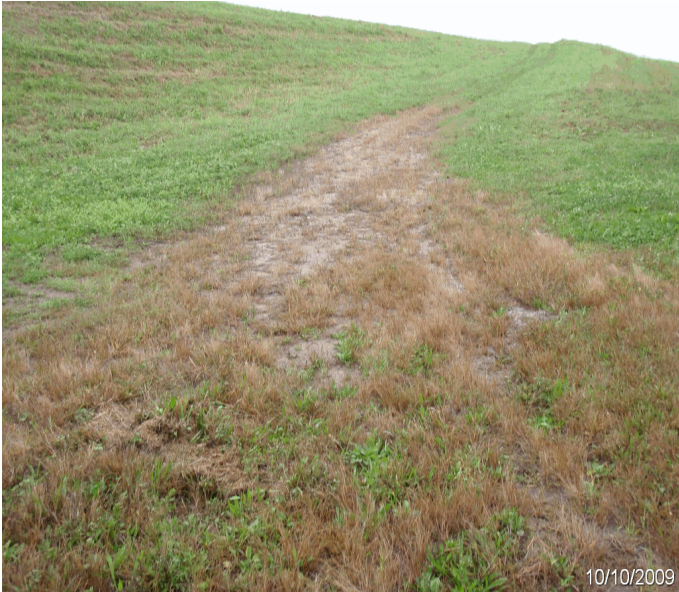
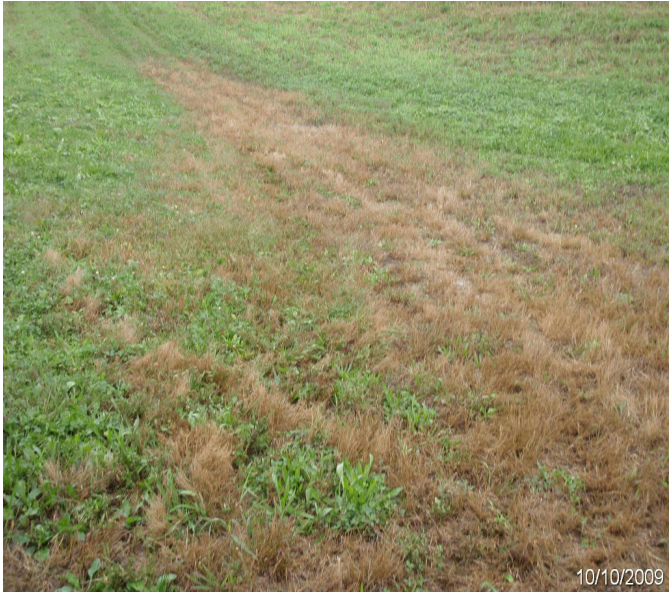
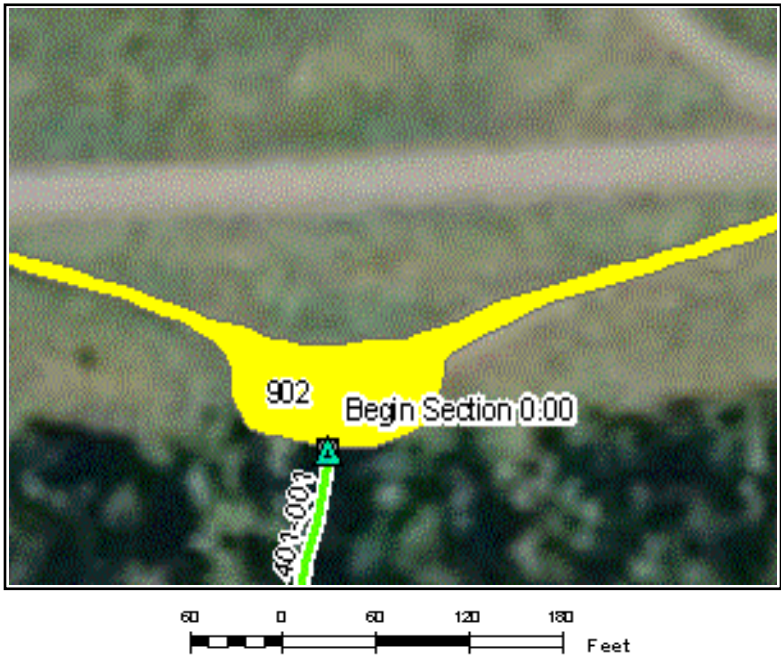
902: North Wilkinson Island Access Parking

Asset Number	Date Visited	Surface Type	Area (Sq Ft)	Condition	Cost to Improve
10043501	10/01/2009	Native	8,236	Fair	2,200

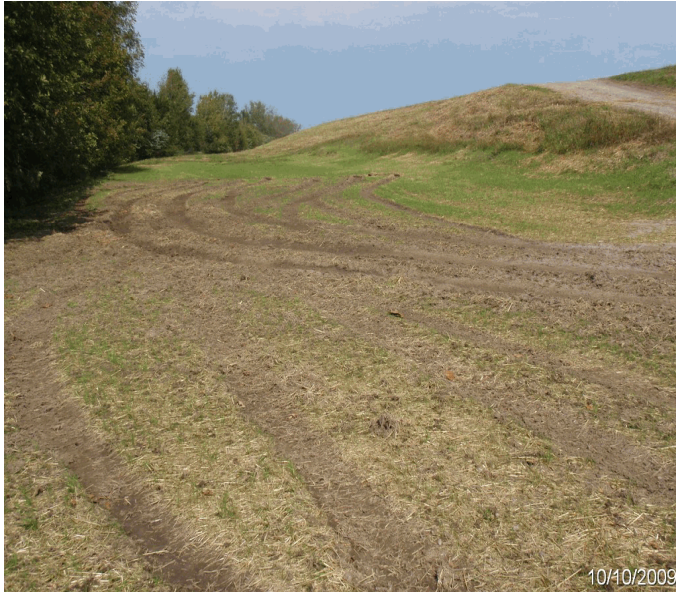
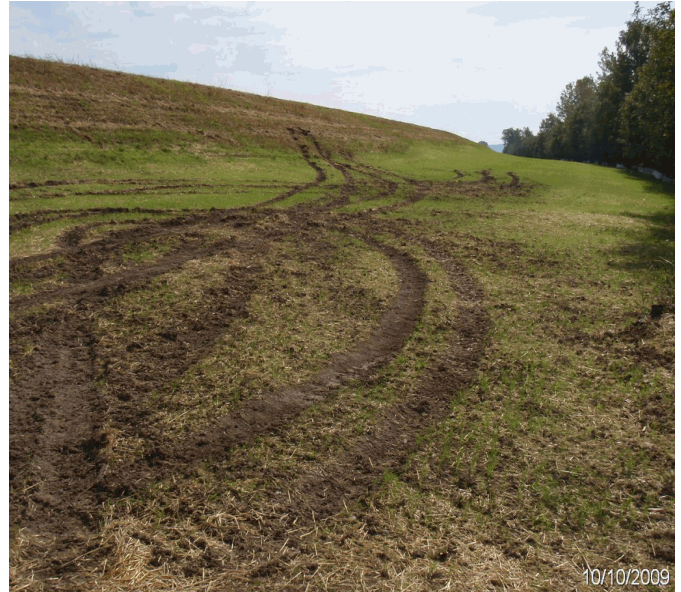
906: Southern Wilkinson Island Parking

Asset Number	Date Visited	Surface Type	Area (Sq Ft)	Condition	Cost to Improve
10061165	10/01/2009	Primitive	17,113	Poor	0
